**ROBERT C. BYRD LOCKS & DAM  
GREENBOTTOM MITIGATION SITE  
EVALUATION REPORT OF THE EXISTING WETLANDS  
ON THE GENERAL JENKINS HOUSE**

Prepared By  
GEOTECHNICAL BRANCH  
DEPARTMENT OF THE ARMY  
HUNTINGTON DISTRICT, CORPS OF ENGINEERS  
HUNTINGTON, WEST VIRGINIA

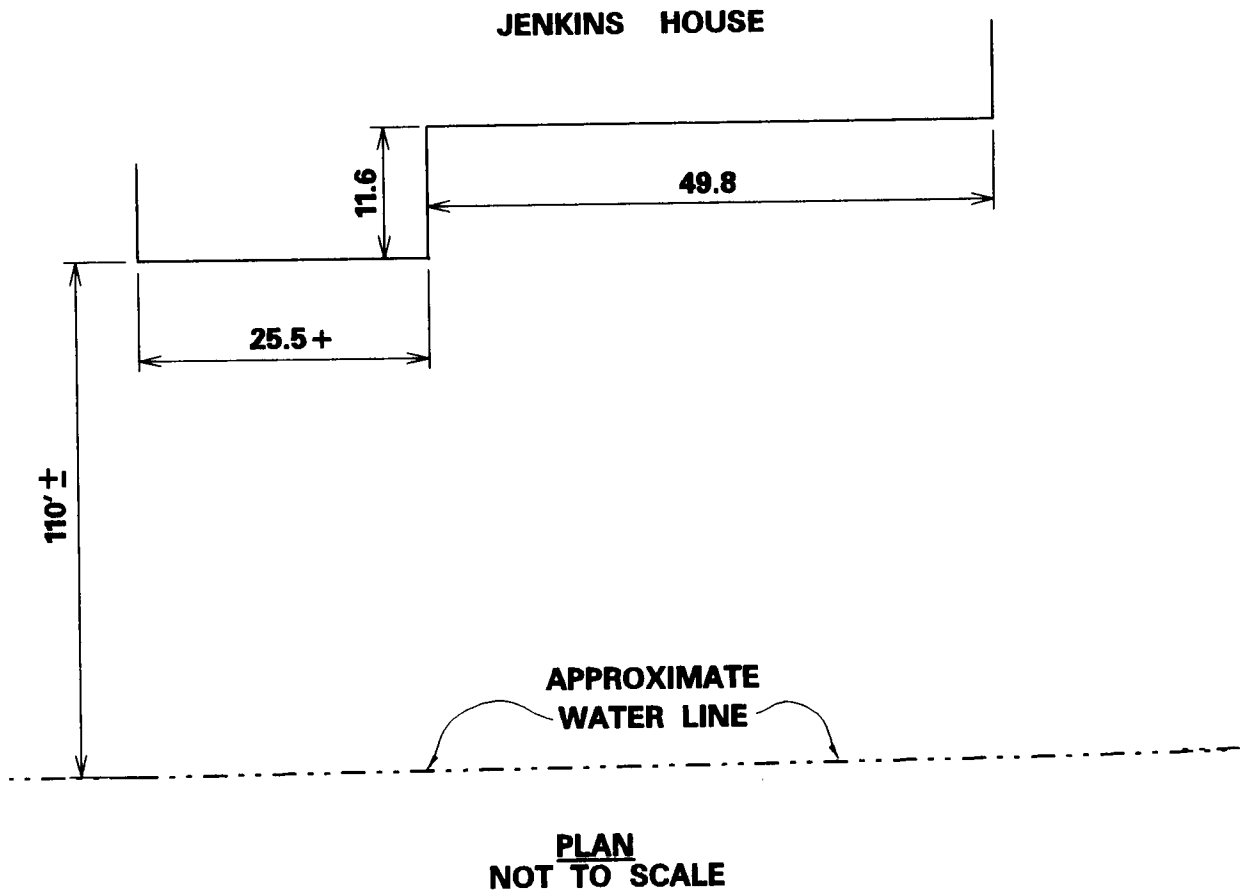
**EXHIBIT I**

On June 17, 1992 a site visit was made to determine the impact of the existing wetland area on the General Jenkins House. A horizontal distance was established from the edge of water to the north exterior wall of the house, Refer to Exhibit I. Elevations at Top of Ground, Basement Floor, and Edge of Water were established using the first floor as a baseline elevation of 100 feet. A visual inspection of the basement was performed. The basement area appeared dry on the date of this inspection, but the presence of mold & mildew damage around the lower wall and floor indicated that there has been water present previously. The basement area showed no apparent distress of the foundation walls or floor, i.e. cracking, bulging, etc.

<b>FIRST FLOOR ELEVATION</b>	100'	
<b>TOP OF GROUND</b>	95.16	
<b>BASEMENT FLOOR</b>	91.66'	
<b>EDGE OF WATER</b>	85.64	<b>DIFFERENCE 6.02'</b>

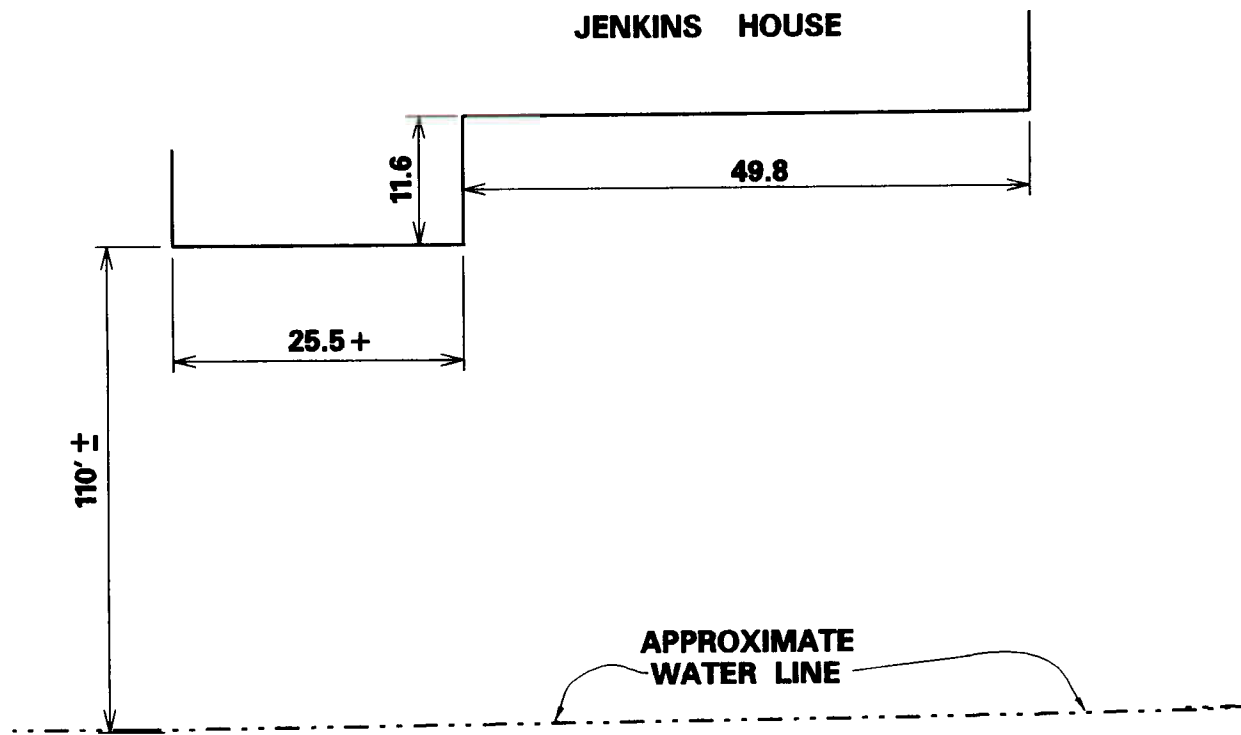
On January 25, 1995 a follow up visit was made to determine if any change in conditions existed that would indicate that the wetland area was adversely impacting the Jenkins House. The horizontal distance was established from the edge of water to the north exterior wall of the house, Refer to Exhibit II. Elevations were taken at Top of Ground, Basement Floor, and Edge of Water using the first floor as a baseline elevation of 100 feet. An inspection of the basement area was made accompanied by Mr. Ken Shaw, West Virginia Department of Natural Resources Wildlife Manager. Standing water was visible in a floor drain located in the basement lavatory. Some mold & mildew damage was noted around the area of the floor drain, see Exhibit III, Photograph Number 3. Mr. Shaw related that during heavy rains and wet periods that water comes in the basement through the concrete block walls, under the door and up through the floor drains. Mr. Shaw commented that an attempt was made to clean out the floor drain, however, the drain was apparently obstructed such that a hand held plumbers snake would not work. The basement area appeared dry on the date of this inspection. The basement area showed no apparent distress of the foundation walls or floor, i.e. cracking, bulging, etc. The ground around the south exterior wall of the house slopes towards the structure as indicated in Exhibit III, Photograph Number 5. This area corresponds to a couple of the points of water entry observed by Mr. Shaw.

<b>FIRST FLOOR ELEVATION</b>	100'	
<b>TOP OF GROUND</b>	95.16'	
<b>BASEMENT FLOOR</b>	91.66'	
<b>EDGE OF WATER</b>	85.49'	DIFFERENCE 6.17'

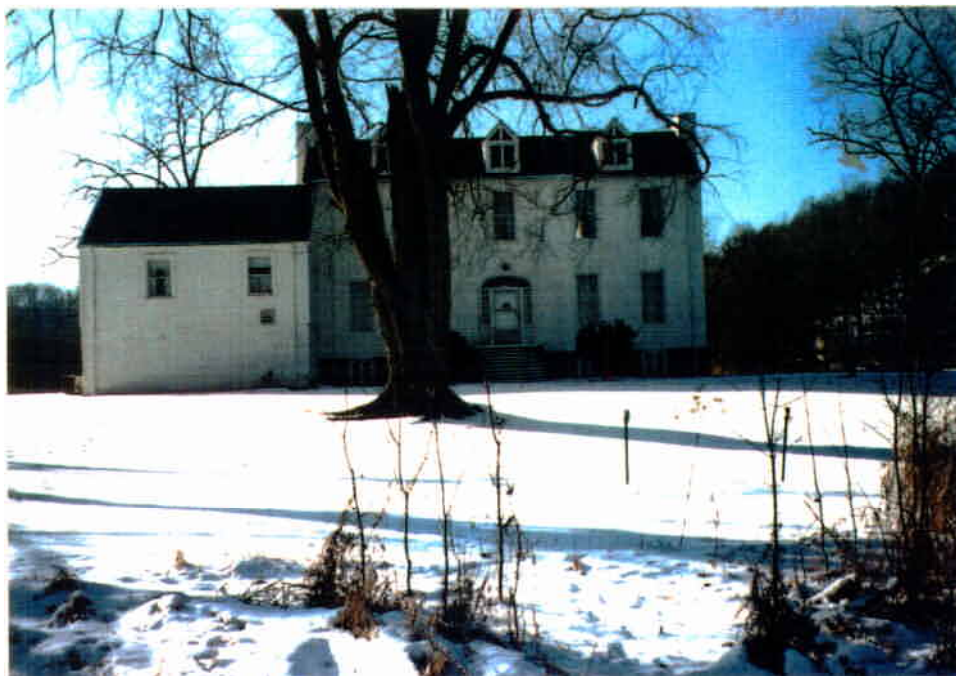
The Jenkins Estate house was constructed in 1835 of sandstone block foundation and brick structure. The original structure is two stories with a full basement. An addition was added on the left side of the existing house in the 1930's. The addition was constructed with a concrete block foundation and wood frame structure. Refer to Exhibit III, Photograph Numbers 1 & 2.

**Photo #1 - Rear of Jenkins House Looking From Wetlands  
January 25, 1995**

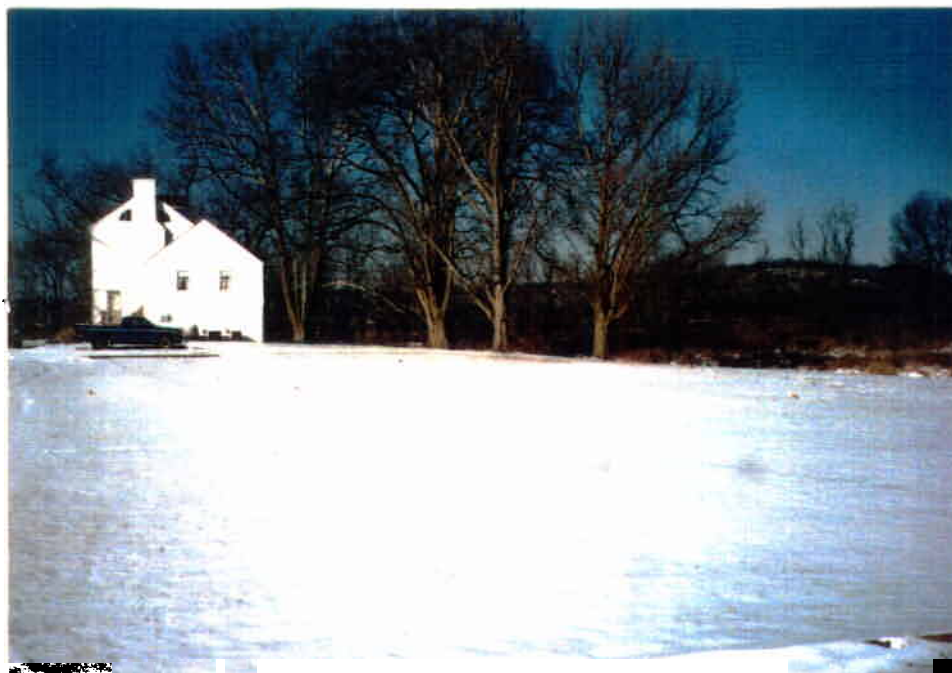
**Photo # 2 - General Jenkins House in comparision to the Wetlands  
January 25, 1995**

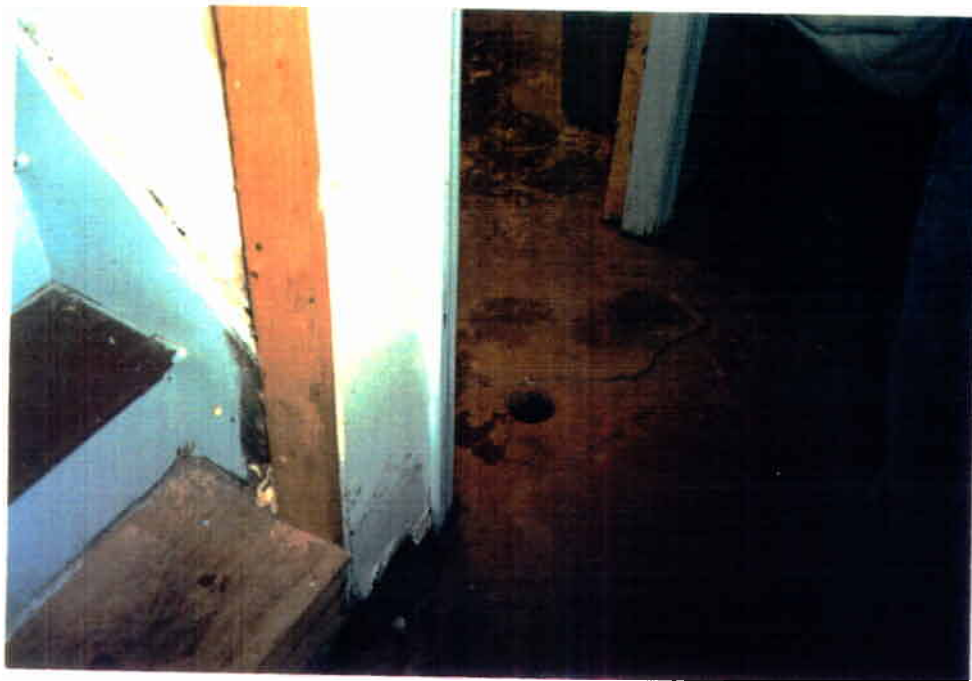
Water enters the basement area of the house only during heavy rains and prolonged wet periods. The majority of the water appears to be surface run off entering under the exterior door and through the walls because of the existing ground slope. The existing drainage system consisting of three floor drains appears to be inadequate to handle the volume of water during these periods. The difference in elevation between the top of water in the wetlands and the basement floor is 6.0 feet plus and the edge of water is approximately 110 feet from the structure. There is no evidence at this time that the wetlands area contributes to any existing problems relating to the General Jenkins House.

Photo #3 - Floor Drain in Basement Floor  
January 25, 1995

It is recommended that the floor drain system be cleaned out and or replaced as necessary. The house should be retrofitted with a foundation drainage system and the area around the house should be sloped away from the structure to provide adequate drainage during heavy rains. Downspouts should be diverted away from the foundation of the house.

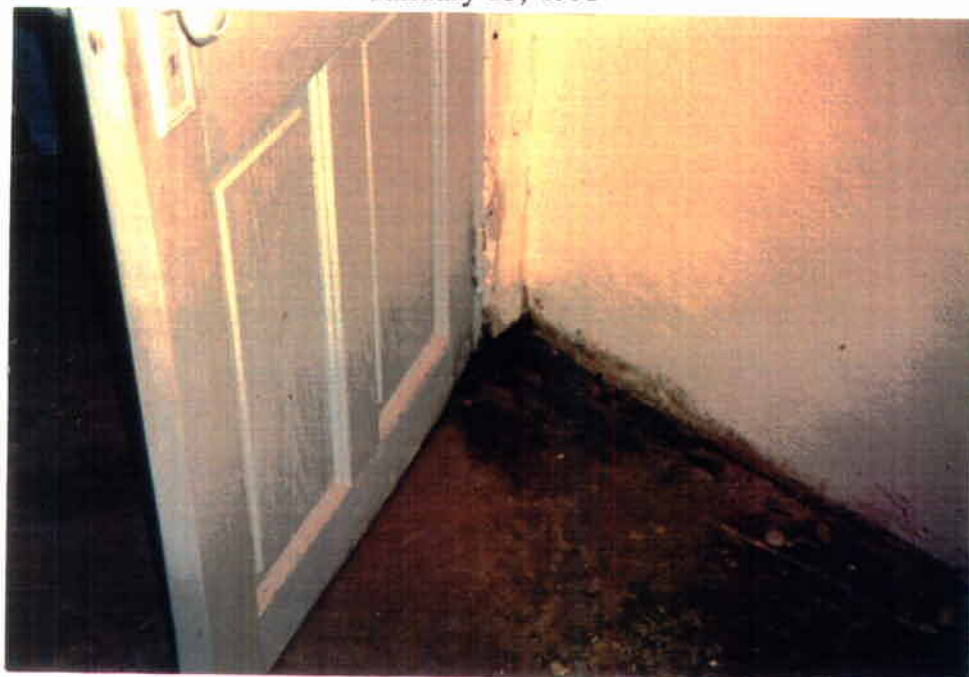
Photo #4 - Damage to Interior Basement Wall  
January 25, 1995

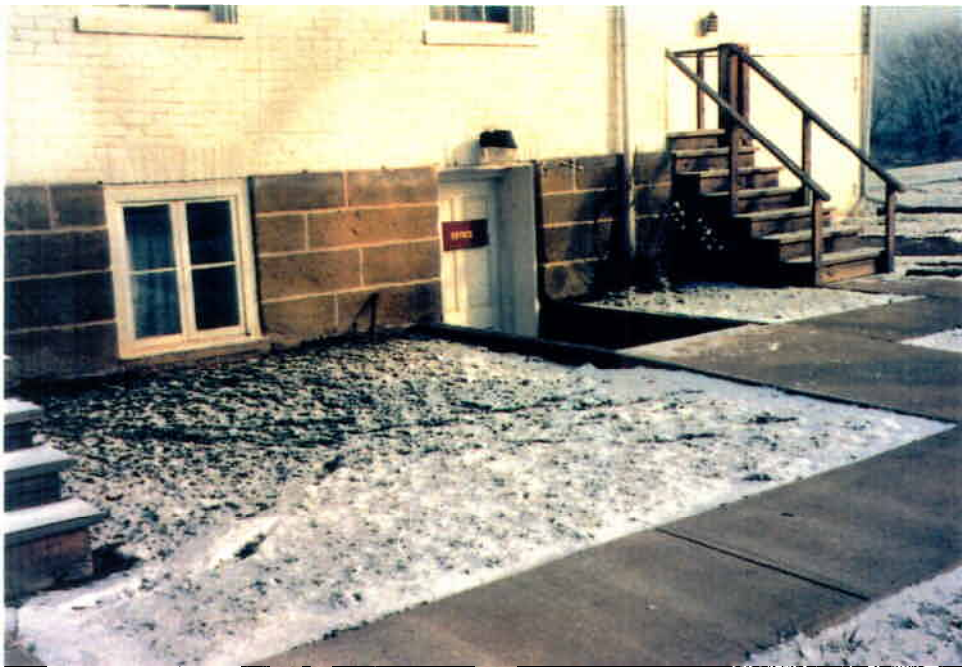
Photo #5 - Showing Recessed Office Door to Ground Elevation  
January 25, 1995
